Name Of Dam: TALBOTT DAM

Inventory Number: VA 14101

PHASE I INSPECTION REPORT

NATIONAL DAM SAFETY PROGRAM

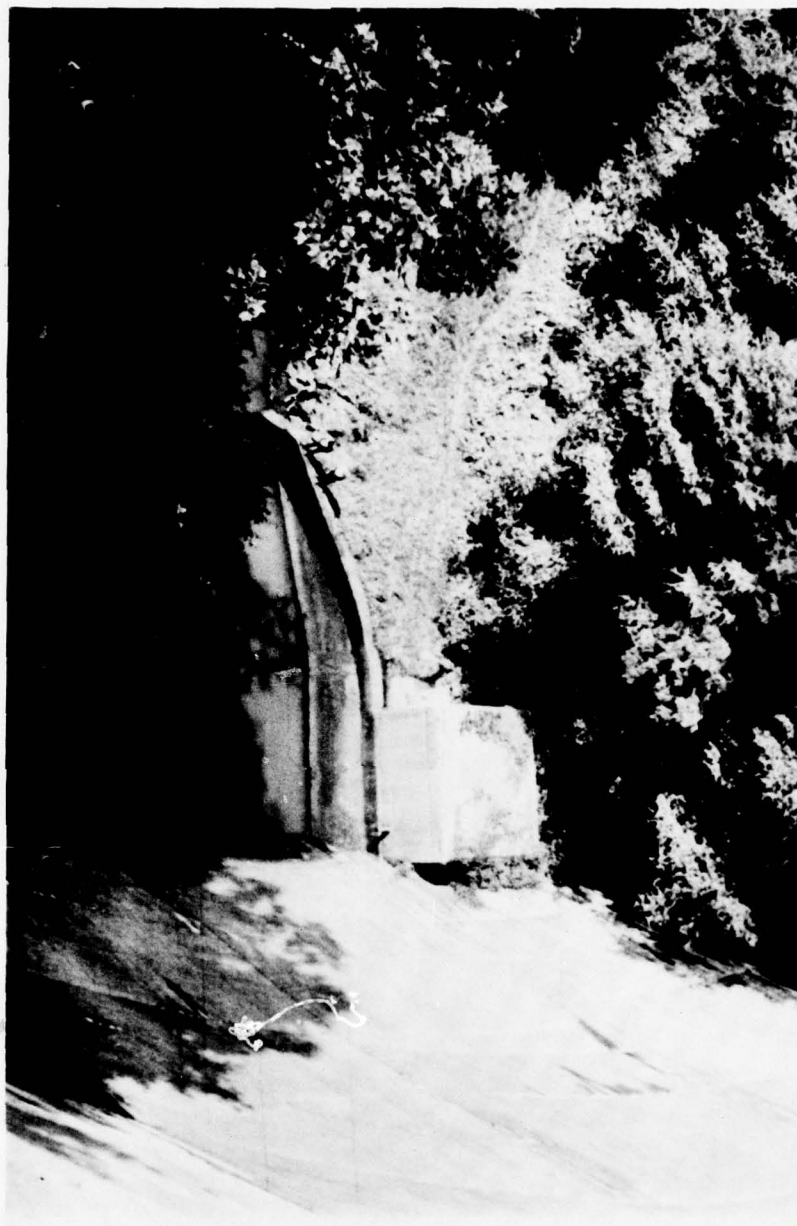
PHOTO 3

TALBOTT DAM-VIEW OF VALUE
HOUSE AND STILLING BASIN TAKEN FROM
THE TOP OF THE DAM
